Manhole Inspection Summary

Manhole # S65G__017MH

Insp Date: **3/17/08 2:23 PM**

Location Address: **440 Bonsal St.**

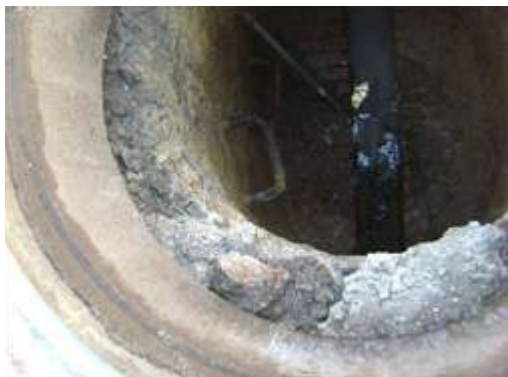
Defect 5

Frame offset defect. Chimmney
Deteriorating

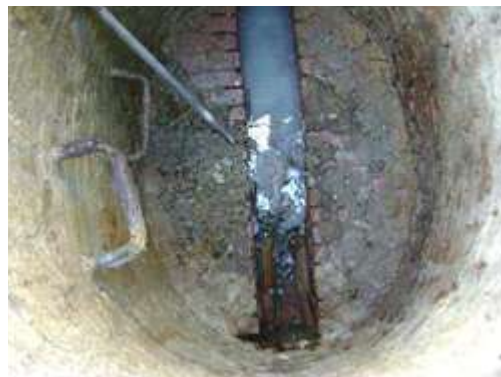
Defect 2

Bench deteriorating, and a blockage in
the channel

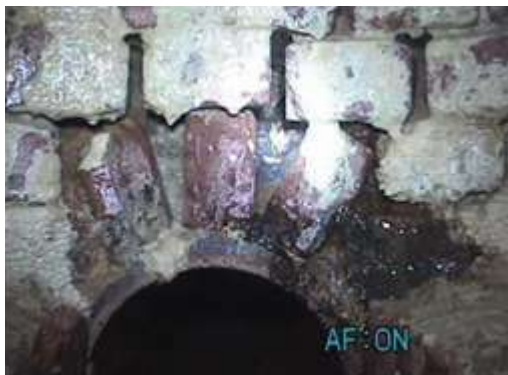
Defect 3

Comments **MANHOLE IS IN BAD SHAPE WITH A SERIOUS DEFECT IN THE BARREL ABOVE THE OUTGOING 12 O'CLOCK. MORTAR IS MISSING AND A VOID IS VISIBLE.**

Void visible wall, above the pipe seal on
12 out.
Infiltration at bricks above 12 out, due to

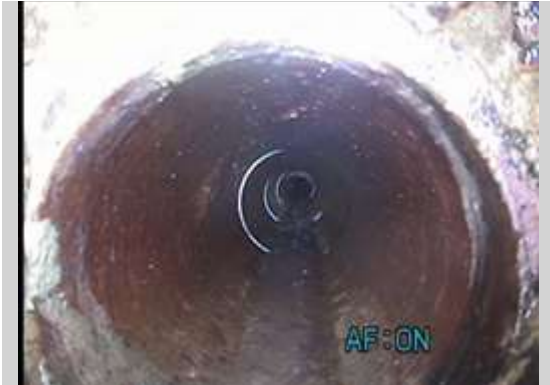
12 O'Clock Outflow

Infiltration: **Evidence** Pipe Seal Cond: **Sound**
